UNITED STATES DISTRICT COURT  
EASTERN DISTRICT OF MICHIGAN

FORD MOTOR COMPANY, a  
Delaware corporation.

**PLAINTIFF'S ORIGINAL  
COMPLAINT**

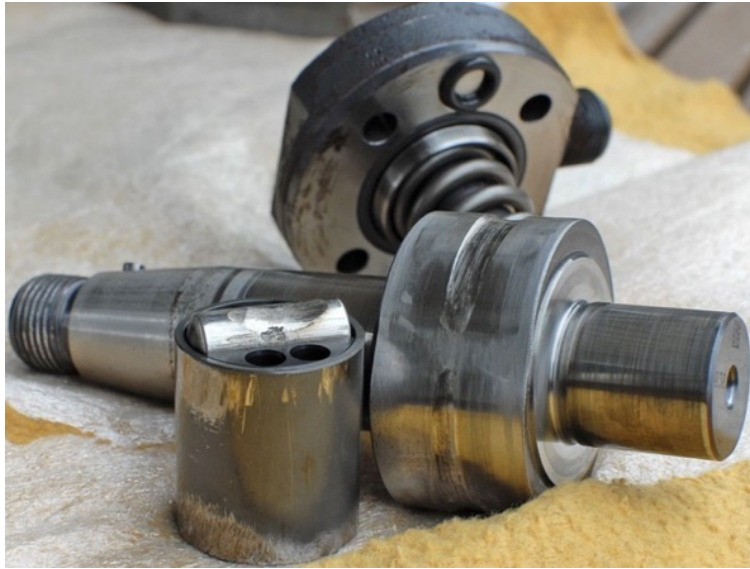
**Figure 6: Wear on the Cam and Roller**

45. The CP4 pump was first introduced in Europe in the 2007 timeframe, and criticism of the pump began almost immediately based on its fragile design and its sensitivity to fuel quality. In addition to the design limitations referenced above, the tappet which houses the roller pin is not prevented from rotating around in its own axis inside the cylindrical pump housing. If the tappet does rotate out of position, the roller pin rotates from parallel to the camshaft, to perpendicular to the camshaft. Once rotated the roller will no longer rotate, and instead the cam slides across the roller, leading to wear and erosion, as a trough is being carved into the cam. The wear and erosion will generate metal shavings that are carried by the fuel throughout the fuel system, including downstream to the sensitive high pressure fuel

injectors. The photograph below shows the severe wear and gouging caused by rotation of the tappet:<sup>11</sup>

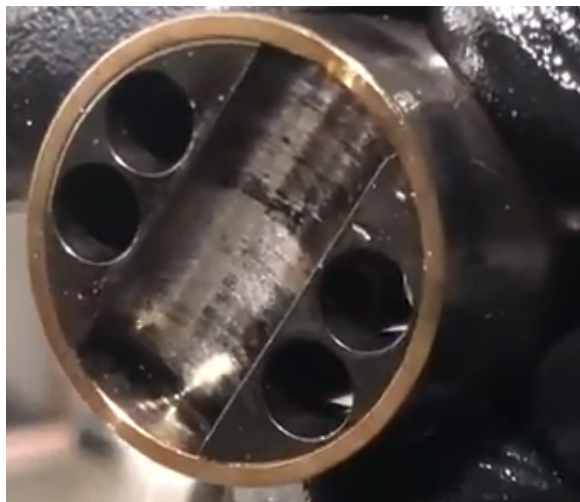
**Figure 7: Wear on the Diamond Coating**

47. When particles enter the roller shoe, and if the film of fluid is not thick enough, the hard diamond-like coating of the tappet roller shoe can wear off. As the coating wears, damage becomes progressively worse, even as the wearing generates more hard and fine particles that can make their way through the fuel system to the injectors. Below is a close-up of the CP4 tappet roller shoe, showing abrasive wear of the coating:

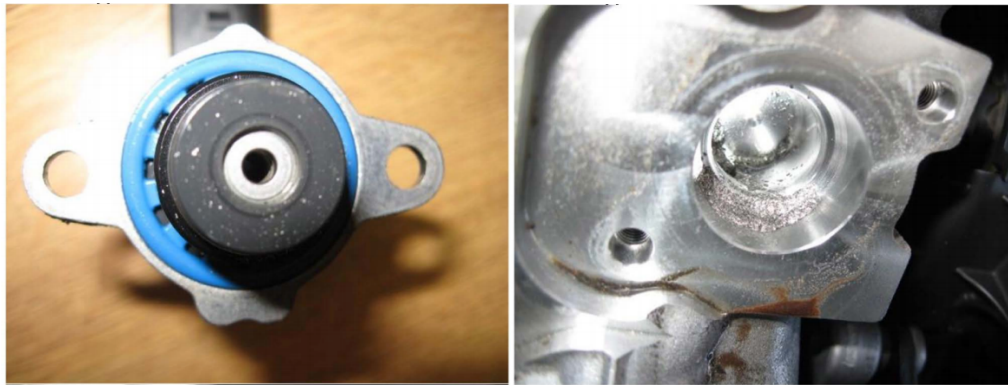
**Figures 11-13: CP4 Pump with Shavings**

81. In September 2009, Bosch, at the time supplying the defective CP4 fuel pump to Audi and Volkswagen, received a notice from Audi about a “3<sup>rd</sup> HPP failure” in the U.S., explaining, “I’m afraid there’s bad news from the U.S.: After 2 failures in the field ... the 3<sup>rd</sup> HPP failure has now occurred in the EC endurance run.”<sup>29</sup> Photos attached to the email show the failed Bosch CP4 fuel pump, replete with metal shavings in the gasket:<sup>30</sup>

82. In August 2009, Audi sent Bosch a failed CP4 fuel pump for analysis after “[t]he high pressure fuel pump failed catastrophically shedding metal shavings throughout the entire fuel system . . . . This car will require a complete new fuel system from tank to injectors and everything in between. This will be a very lengthy repair (weeks) . . . . We need to determine if component failure or bad fuel is to blame.” March 7, 2011 Bosch submission to NHTSA in response to Inquiry No. INRD\_EA11003, document entitled, “INRD\_EA11003-59347P.pdf,” at 35. Thereafter, on September 1, 2009, Bosch responded to Audi with the following analysis note from their failed pump inspection: “Gentleman, [t]he pump mentioned below was analyzed. The result of the finding is sand-like particles in the fuel. ***Defect caused by customer.***” *Id.* at 38 (emphasis added).<sup>31</sup>
